# MONUMENT RECORD

Corner ID: **BeBI\_W01**

## Quarter Corner

Section 1- T10N-R02W, 2nd P.M.

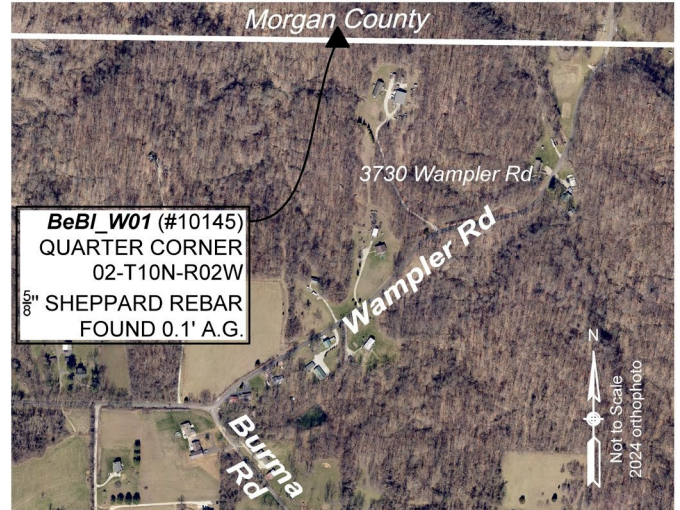
### MONUMENT LOCATION SKETCH:

(#10145) 5/8" diameter rebar with chewed, SHEPPARD LS#20100021 cap on top found with top 0.1' above ground, ±4' South of old (laying on ground) east-west fence remnants.

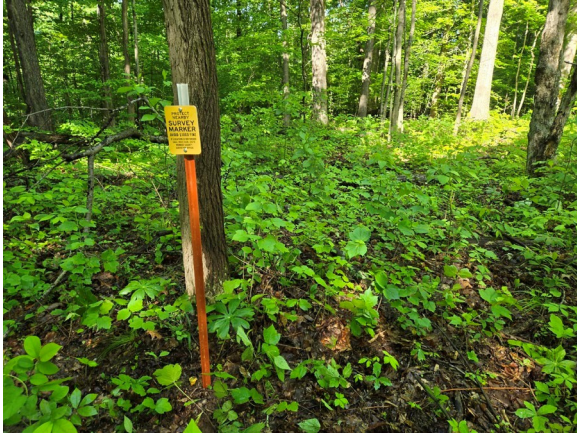
Photo Orientation & Description: From East looking West

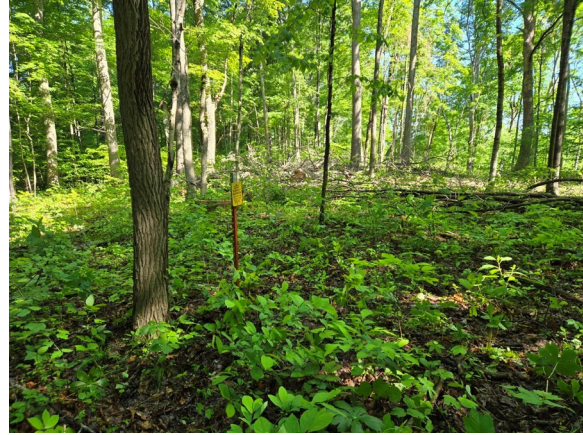
Photo Orientation & Description: From South looking North
